INDOOR AIR QUALITY ASSESSMENT

**Weston Public Library
87 School Street
Weston, Massachusetts**

Prepared by:
Massachusetts Department of Public Health
Bureau of Environmental Health Assessment
February, 2002

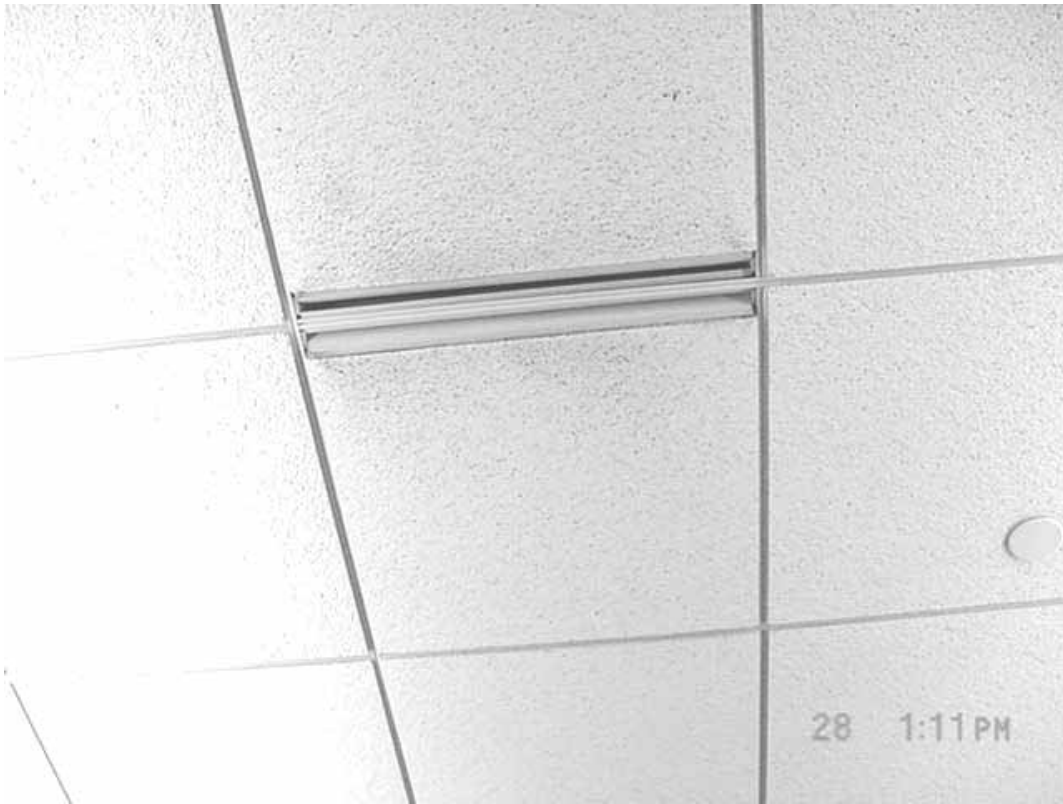
Picture 1

A heating, ventilating and air conditioning (HVAC) system, consisting of three air handling units (AHUs), provides ventilation through ducted wall or ceiling vents (see Picture 1). Air is returned to the AHUs by wall and/or ceiling-mounted grilles (see Picture 2) via ductwork. This system was operating throughout the building on the day of the assessment. To maximize air exchange, the BEHA recommends that both supply and exhaust ventilation operate continuously during periods of occupancy.

Slotted Ceiling-Mounted Supply Vent

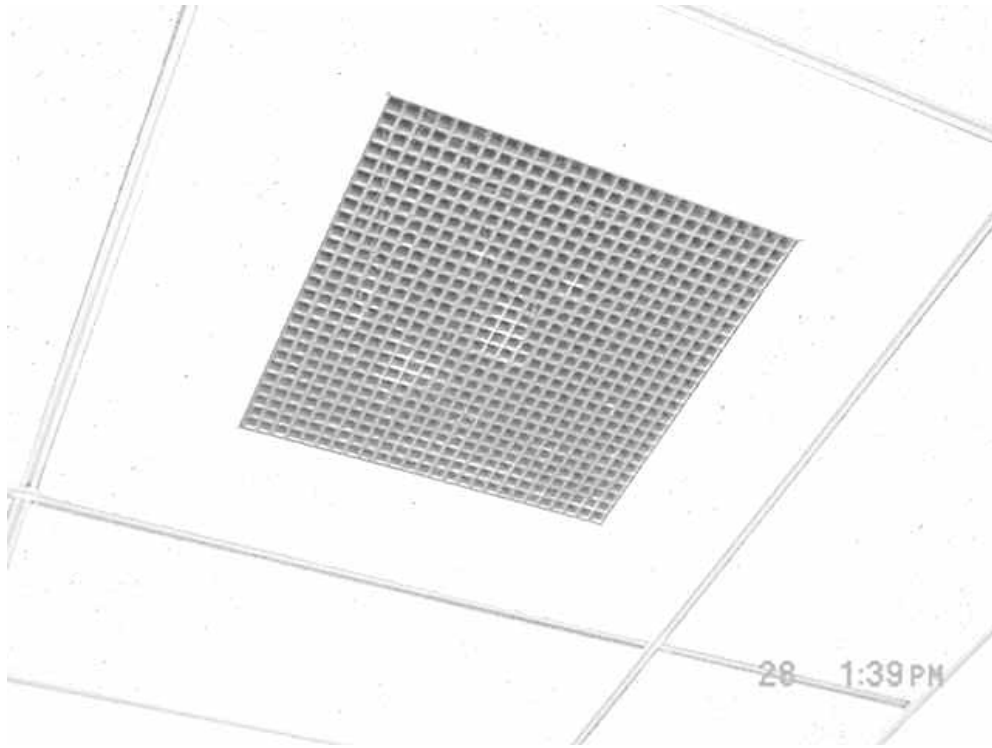
Picture 2

Ceiling-Mounted Return Grate

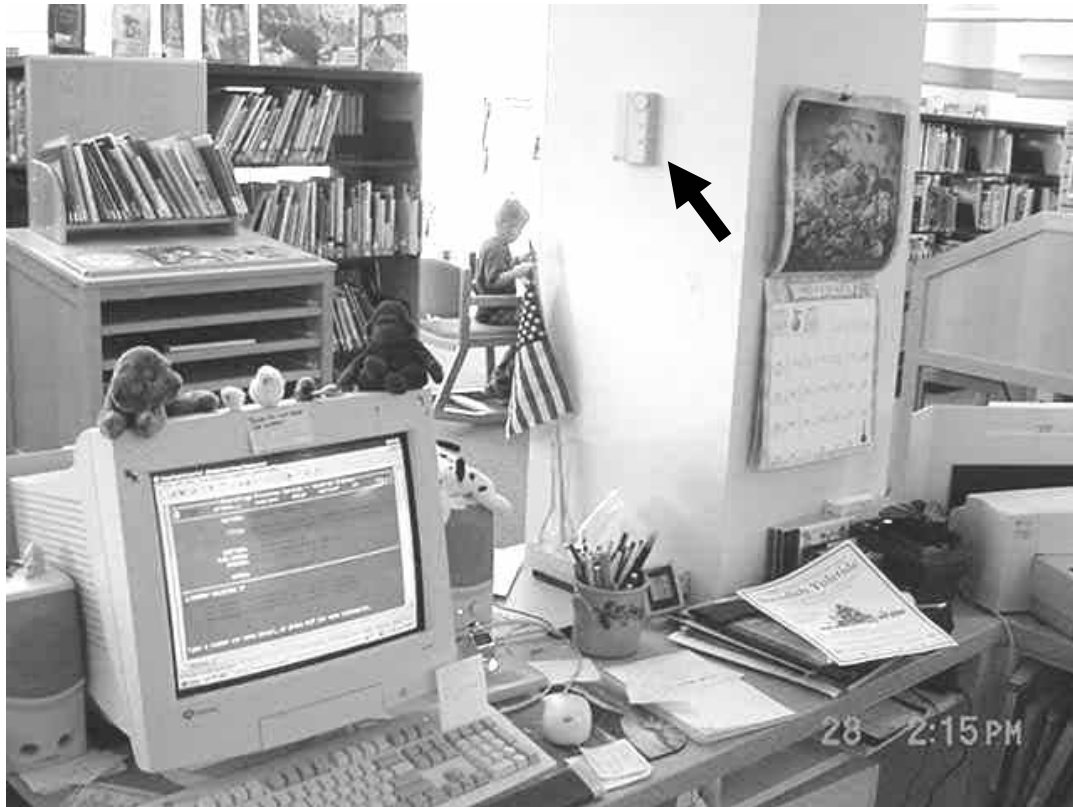
Picture 3

A number of complaints of uneven heating and cooling were expressed to BEHA staff, specifically excess heat in the computer room and reports of extreme cold in the Library Director's office. Also noted was a thermostat near the children's library circulation desk mounted on a support column in close proximity to a computer monitor

(see Picture 3). Heated air rising from operation of the computer would activate the thermostat, which would in turn activate the HVAC system to provide cold air to this area during summer months. In winter, the HVAC system would be deactivated by heated air from the computer interacting with the sensors in the thermostat. The location of the thermostat can make it difficult for the ventilation system to control temperature in this area. In many cases concerning indoor air quality, fluctuations of temperature in occupied spaces are typically experienced, even in a building with an adequate fresh air supply.

Computer Station in Close Proximity to Wall-Mounted Thermostat in Children's Library

1. Once roof repairs have been confirmed, replace all water-damaged ceiling tiles and wallboard. Inspect above and behind these areas for microbial growth and disinfect with an appropriate antimicrobial where necessary.
2. Continue to work with HVAC engineering firm to resolve relative humidity issues in the community room. Heating, cooling and general ventilation complaints should be communicated with the HVAC engineer in order to establish corrective actions for improvement of airflow and temperature control.
3. Consider having the HVAC system balanced every five years by an HVAC engineering firm in accordance with SMACNA guidelines (SMACNA, 1994).
4. Re-calibrate and/or replace thermostats as necessary to maintain control of comfort.
5. Relocate computer away from thermostat in children's library.

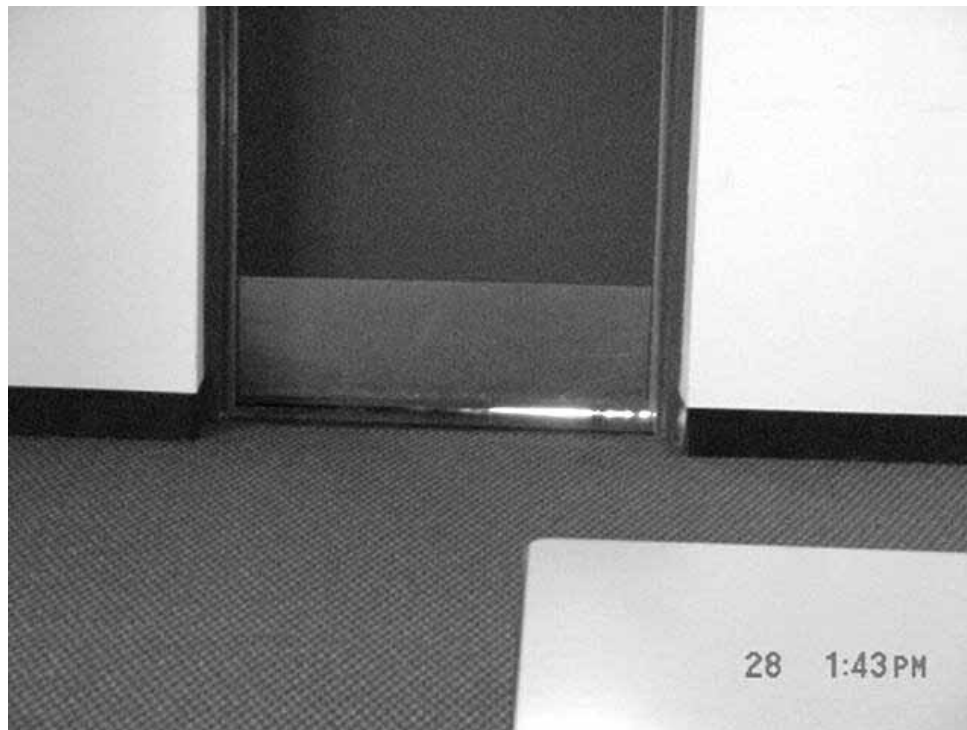
Picture 4

Light Penetrating through Space Beneath Community Room Door

8. Seal space beneath door in community room with weather stripping and a door sweep to prevent drafts and/or water penetration.
9. Install a water impermeable barrier (e.g., plastic or rubber) beneath water fountains to prevent water damage and potential microbial growth in carpeted areas.

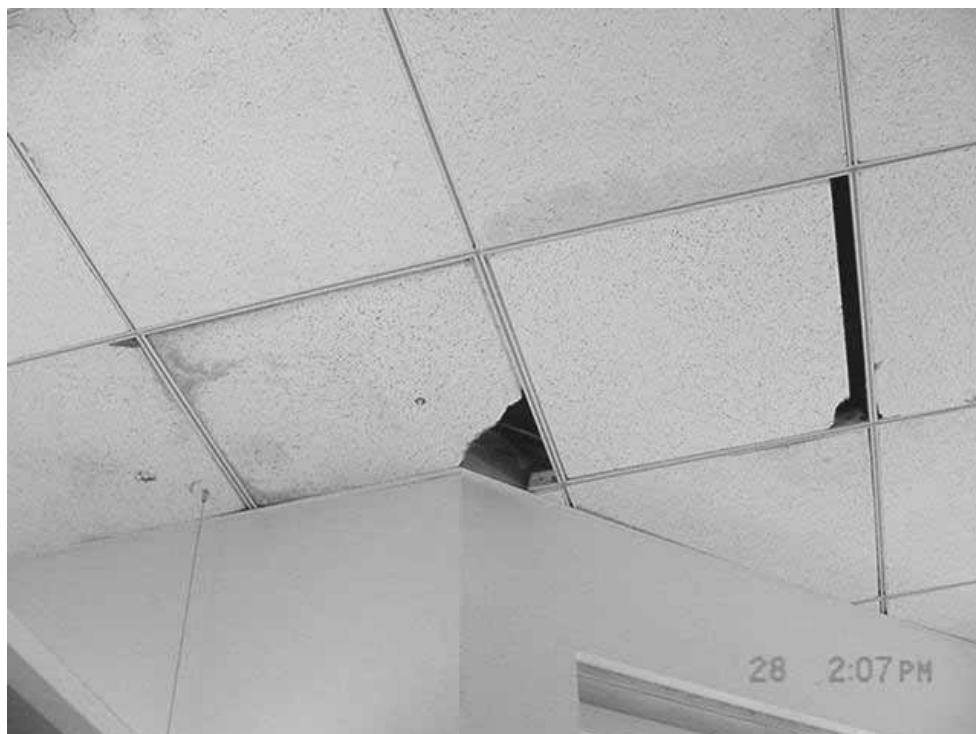
Picture 5

Several areas had water-damaged walls and/or ceiling tiles (see Picture 5), which are evidence of roof or plumbing leaks. Water-damaged ceiling tiles can provide a source of microbial growth and should be replaced after a water leak is repaired. It was reported by Ms. Drake and Mr. Niland that the building has had a history of roof leaks due to incompatible building materials and that the roof had recently been replaced. Building staff were awaiting a wind-driven rainstorm in order to determine if leaks were repaired prior to replacing ceiling tiles.

Water-Damaged Ceiling Tiles

10. Continue to work with roofing contractor to identify and repair any existing water leaks and replace any remaining water-stained building materials. Examine above and around these areas for microbial growth. Disinfect areas of water leaks with an appropriate antimicrobial as needed.

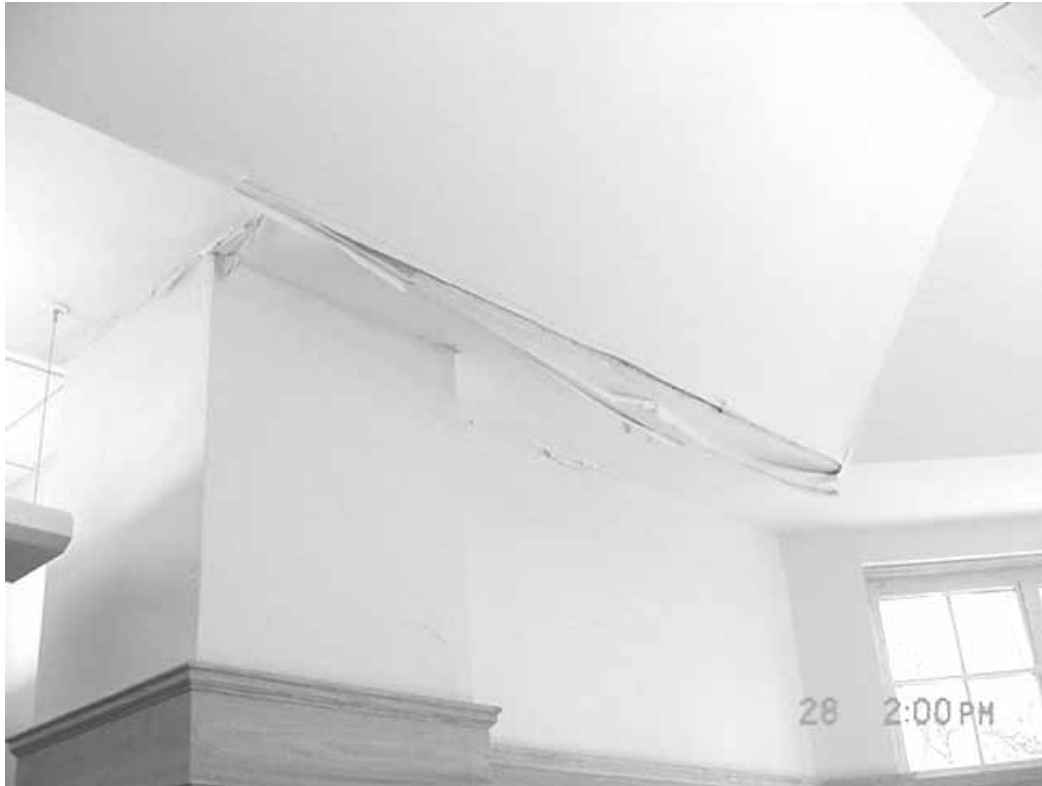
Picture 6

Water damaged wallboard was noted in the children's area, reportedly as the result of a frozen roof drain (see Picture 6). To prevent this contingency, a heating element was wired into the drainage system. As stated previously if porous building materials become wet repeatedly, they can provide a medium for microbial growth.

Water-Damaged Wallboard in Children's Library

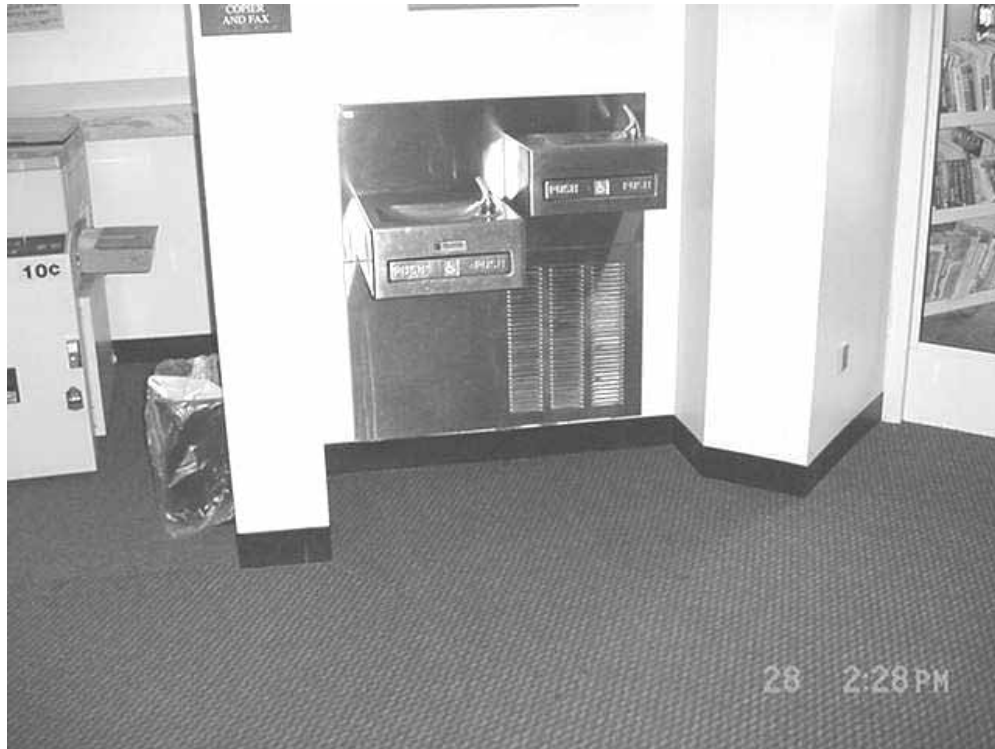
Picture 7

Water fountains were noted installed over carpeted areas (see Picture 7). Spills or overflow from usage can result in wetting of the carpet, which can lead to mold growth.

Water Fountains Installed over Carpeting

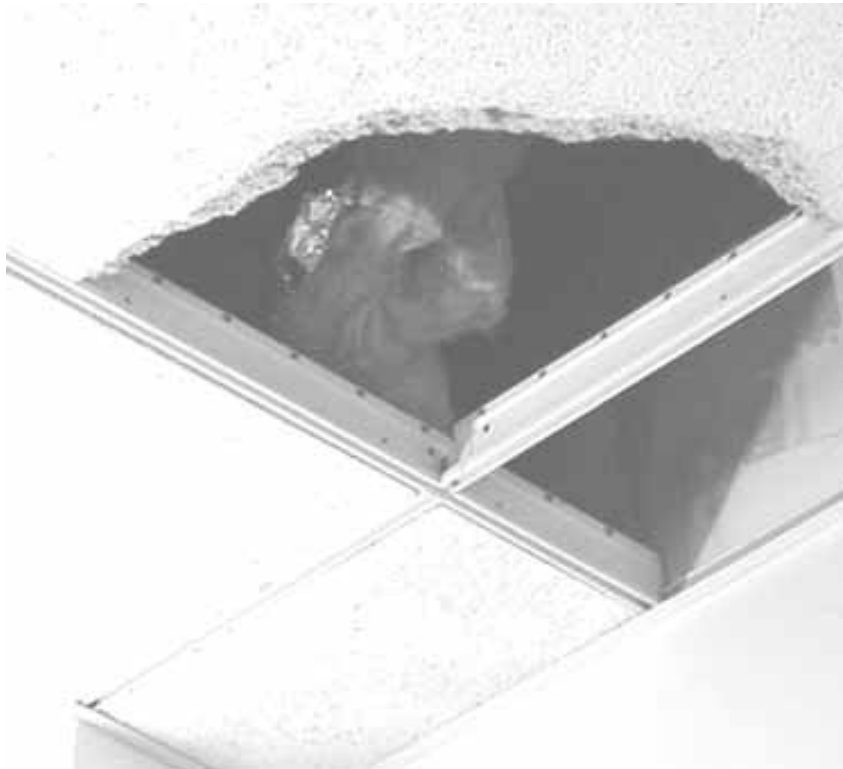
Picture 8

As discussed, some areas had missing/damaged ceiling tiles; fiberglass insulation in the ceiling plenum was exposed in the storytelling area (see Picture 8). Missing ceiling tiles can provide a pathway for the movement of odors, fumes, dusts and vapors into occupied areas and should be replaced after work is completed. In addition, fiberglass particles can be an eye, skin and respiratory irritant and should be contained.

Exposed Fiberglass in Children's Library

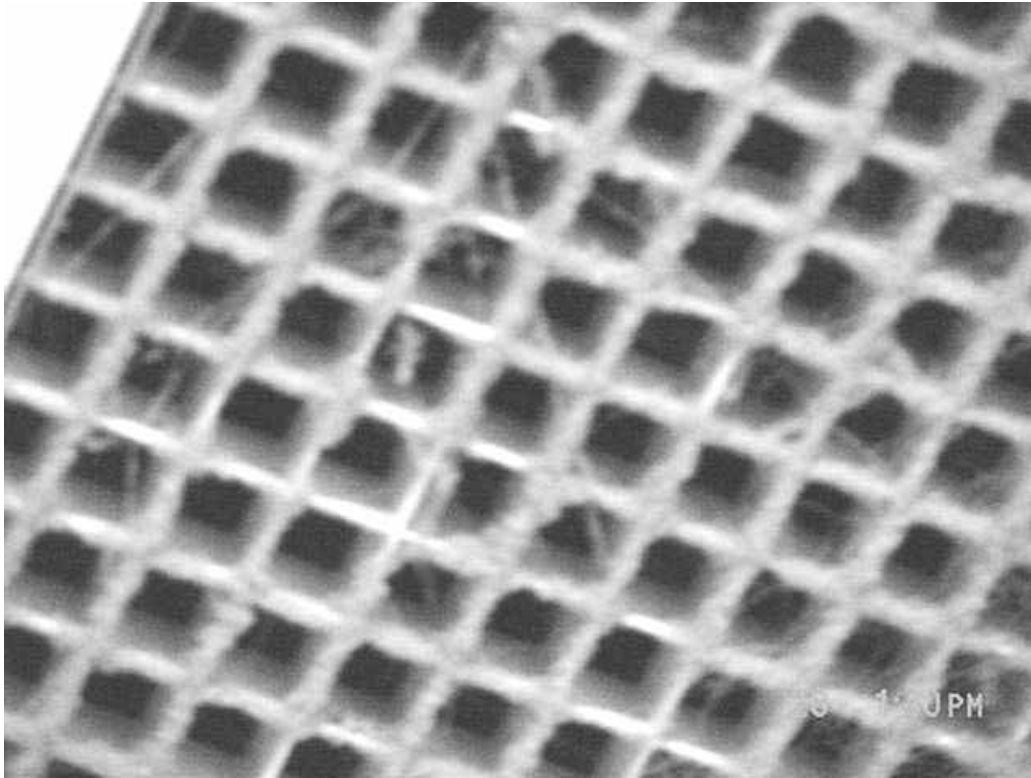
Picture 9

Dirt and dust accumulation was noted on the return vent in the circulation workroom (see Picture 9). Aerosolized dirt and dust can provide a source of eye and respiratory irritation to certain individuals. In addition, these materials can accumulate on flat surfaces (e.g., desktops, shelving and carpets) in occupied areas and subsequently be re-aerosolized causing further irritation.

Accumulation of Cobwebs and Dust on Ceiling-Mounted Return Vent

11. Clean return/exhaust vents periodically to prevent the accumulation of dirt and dust.
